# Solution guide: WLAN dongle connect to the router have an alarm of "Failed to scan the WiFi list!"

# WLAN dongle连接路由器时提示扫描路由列表失败解决方法指引

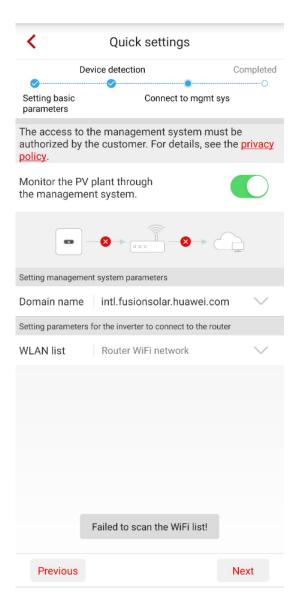
02312DHF function module, inverter external WLAN Dongle, have an alarm of "Failed to scan the WiFi list!" when click the WLAN drop-down list;

Step 1: When the "Failed to scan the WiFi list!" appears, hold the App keep the page displayed, unplug the WLAN dongle. After the LED is off, plug it back in the USB port.

Step 2: Wait for the WLAN dongle's LED turn to blink at short intervals (on for 0.2s and then off for 0.2s)

Step 3: In the App, click the WLAN list drop-down menu and select the WIFI name you want to connect to. (Only one chance)

Step 4: If the selection is not correct in step 3, please repeat steps 1~3;

Step 1: When the "Failed to scan the WiFi list!" appears, go to the "Communication configuration"-->"Router connecting settings" page;

Step 2: Click the WLAN list input box, tap the WiFi name and password in manual. Click the "Connect" button.

Step 3: re-do the quick setting.

Please contact to the Service team, obtain the SPC107 software version of the inverter, and then re-do the quick setting.

Fusionsolar App 2.3.7 version will release at 2019/10/27, this version will integrate the SUN2000MA SPC107 and suggest to upgrade.

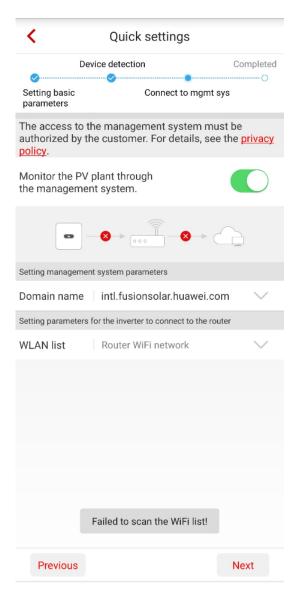
02312DHF功能模块,逆变器外置WLAN Dongle,点击WLAN list下拉菜单时,提示"扫描路由列表失败"。

步骤1: 当出现"Failed to scan the WiFi list!"提示时,请将WLAN dongle拔下,待Dongle LED灯灭,重新插回USB接口;

步骤2: 等待WLAN dongle LED灯变成红灯快闪 (0.2s亮, 0.2s灭);

步骤3: 重新进行一键开局,进入 "connect to mgmt sys"页面,点击WLAN list下拉菜

单,选择需要连接的WIFI名称。(只有一次机会);

步骤4: 若在步骤3未选择正确,请重新进行步骤1~3;

步骤1: 当出现 "Failed to scan the WiFi list!" 提示时, 进入通讯设置->路由连接设置界

面;

步骤2:点击WLAN列表输入框,手动输入WIFI名和密码,点击连接;

步骤3: 重新进行一键开局;

联系客服,获取SUN2000MA SPC107软件版本,对逆变器升级后重新进行一键开局; Fusionsolar App 2.3.7版本将于2019/10/27发布,将内置SUN2000MA SPC107软件版本并建议客户升级;
